Environmental Condition of Property

NON-BRAC PROPERTY PARCELS: B4-1, B4-2, B4-3, B1-B, B4-5, B4-6, B4-7, B4-8, B4-9, B4-10, B4-11, B4-12, B4-13, B4-14, B4-15A, B4-15B, B4-16, B4-17, B4-18, B4-19, B4-20, B4-21, B4-22, B4-23, B4-24, B4-25 and the Credit Union Parcel Kalaeloa, Oahu, Hawaii

May 2008

26. PARCEL B4-21 (LAND COURT LOT NO. 13062-A)

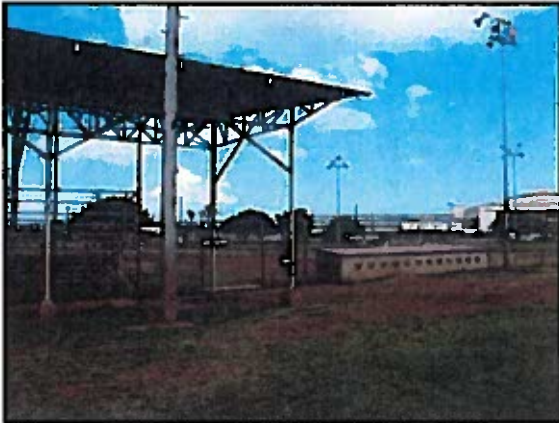
11 June 2007

Overview of structures located at the sports complex south of Saratoga Avenue.

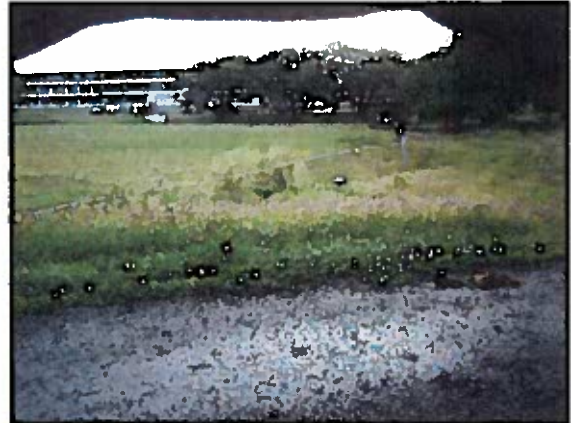
28 December 2007

View to the southeast across Toulon Field towards Buildings 960.

- Building 960:** Lead concentrations in excess of 600 ppm were identified in Building 960 (DoN 1994). Surfacing materials were noted in weathered and damaged condition during the 2007 VSI.

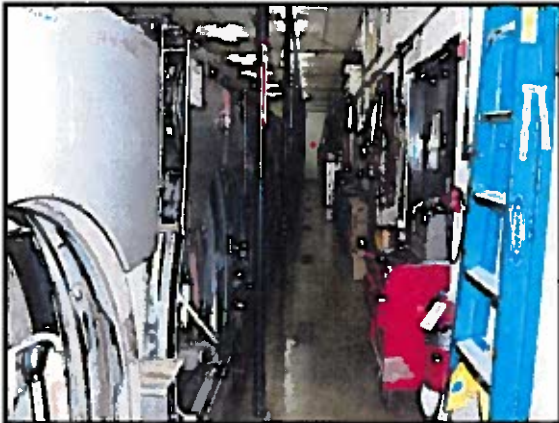
30 August 2007

Area behind the bowling lanes in Building 1831.

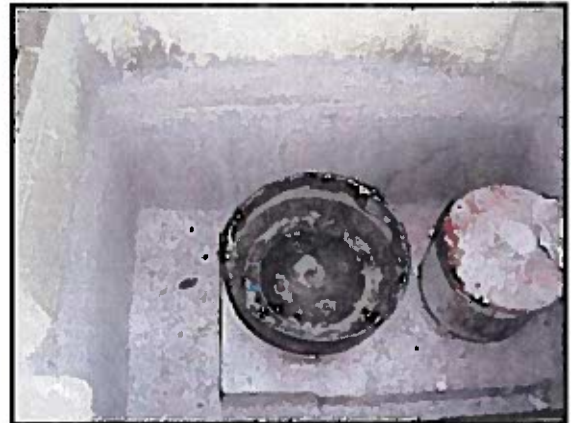
30 August 2007

Bowling ball polishing area in maintenance area of Building 1831.

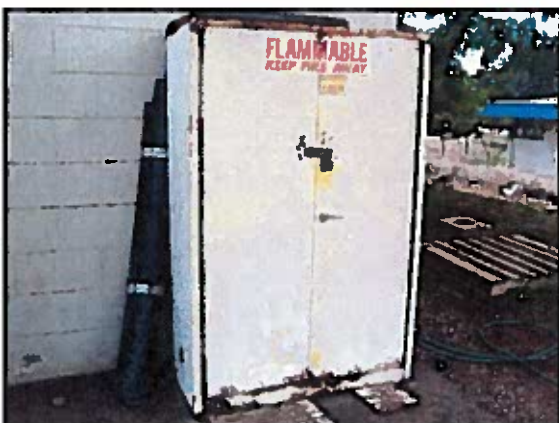
30 August 2007

Flammable materials storage locker located adjacent to Building 1831 which could not be accessed during the 2007 VSI.

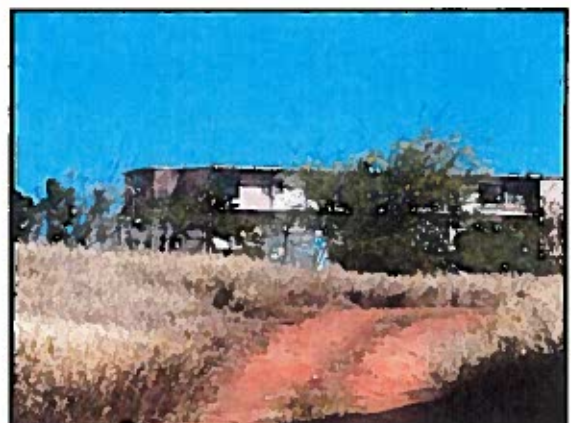
11 June 2007

Area south of Building 1924, including pad mounted transformer S1924

- Structure S1924: Structure S1924 is an electrical substation. Since this structure is not considered habitable, no lead-based paint survey has been conducted. Based on the age of the structure, lead-based paint is potentially present on the structure. Surfaces were noted to be in fair condition during the 2007 VSI.

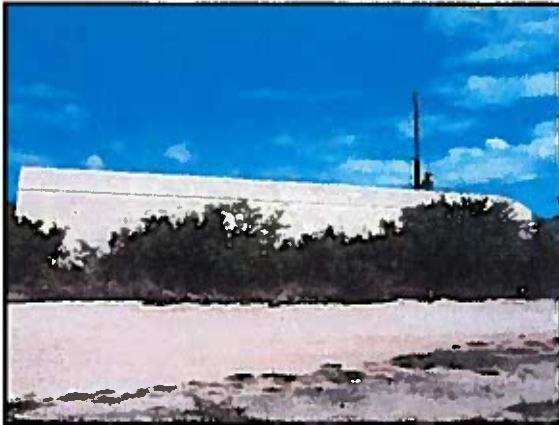
29 August 2007

Exterior view of Building 1562 and area south of Building 1562

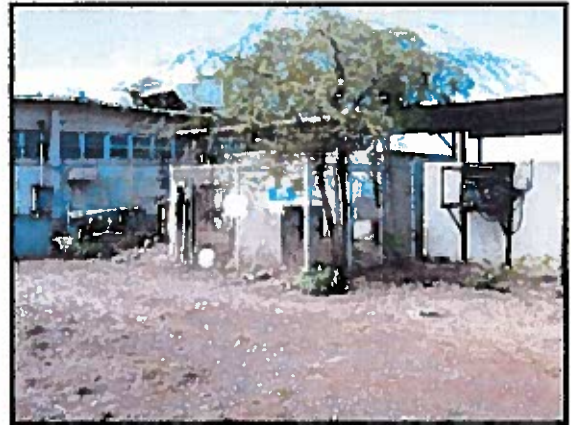
29 August 2007

Fenced compound surrounding transformer S1759

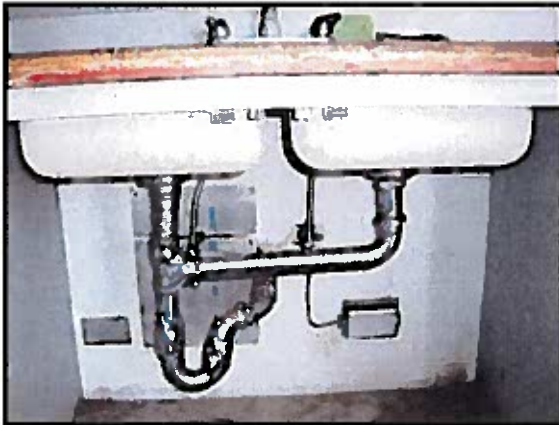
29 August 2007

Potential ACM on the underside of sinks at the bathroom facility at Nelson Field

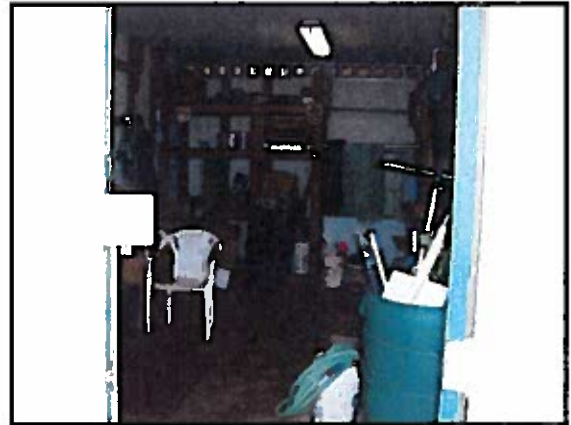
29 August 2007

Janitorial and maintenance supplies in Building 1958

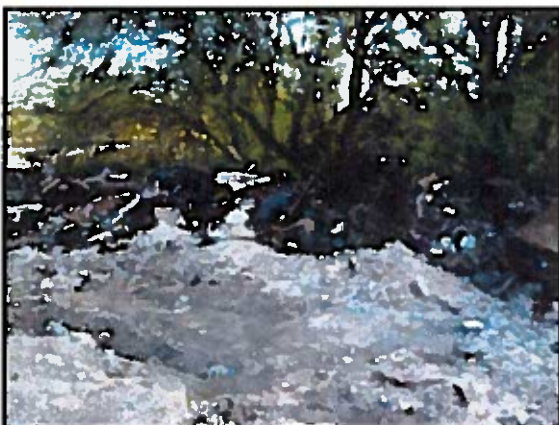
15 November 2007

Miscellaneous solid waste piled on ground south of Vinson Avenue

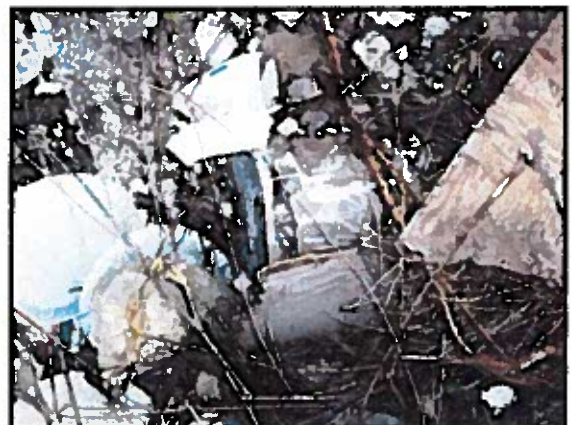
15 November 2007

Damaged battery located in pile of miscellaneous solid waste near Vinson Avenue

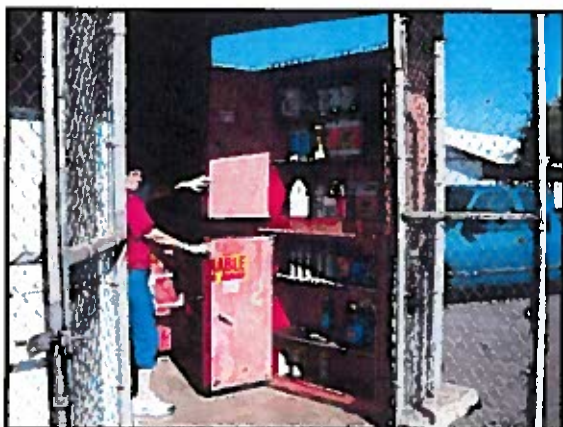
29 August 2007

Flammable and hazardous materials storage adjacent to Building 1966

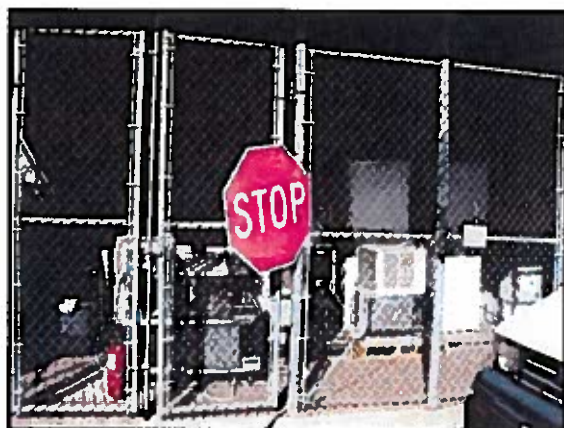
29 August 2007

Used air conditioning units stored in area marked "90-Day Accumulation Area" awaiting transport by DRMO at Building 1966

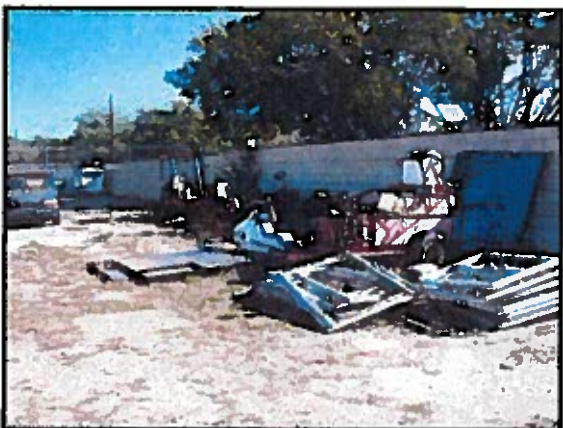
29 August 2007

Miscellaneous materials awaiting transport by DRMO in fenced area behind Building 1966

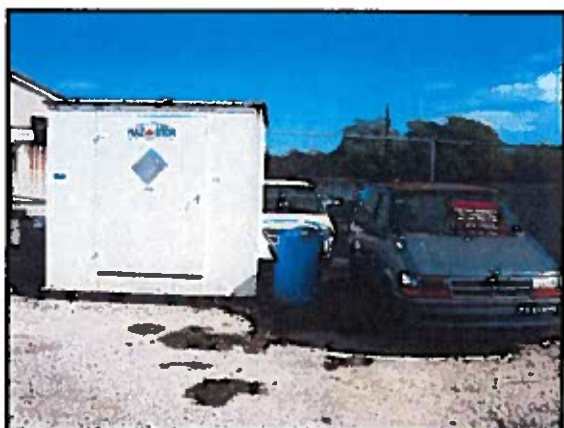
29 August 2007

Hazstor container filled with paint and fuel for maintenance activities, near Building 1966

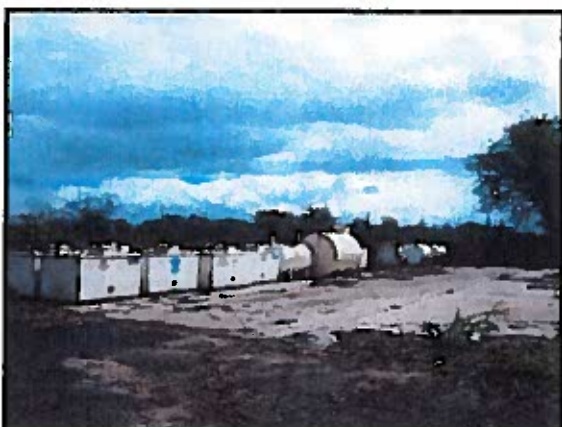
29 August 2007

Out of service ASTs located on concrete pad in area of former Building 1569

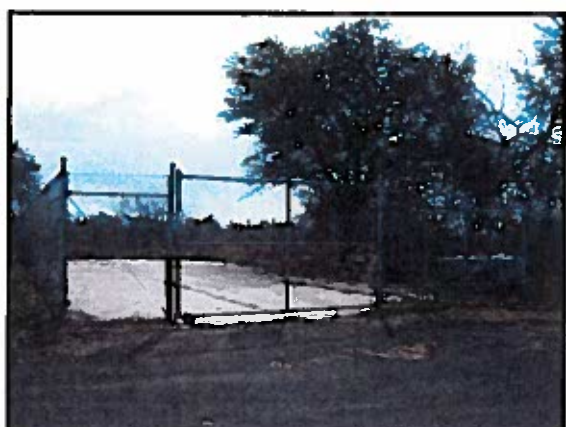
29 August 2007

Drums stored in fenced compound on concrete pad in area of former Building 1569

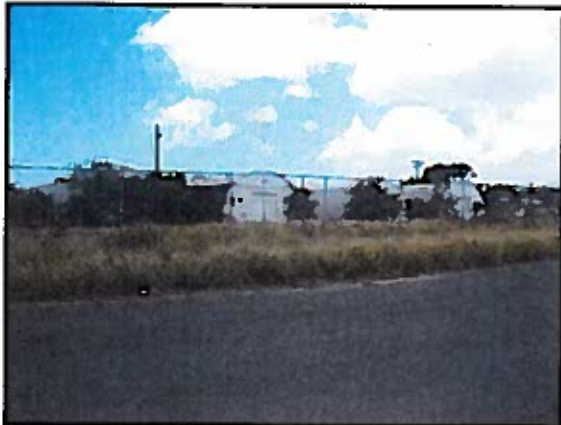
15 April 2008

View facing northwest of the former MWR warehouses.

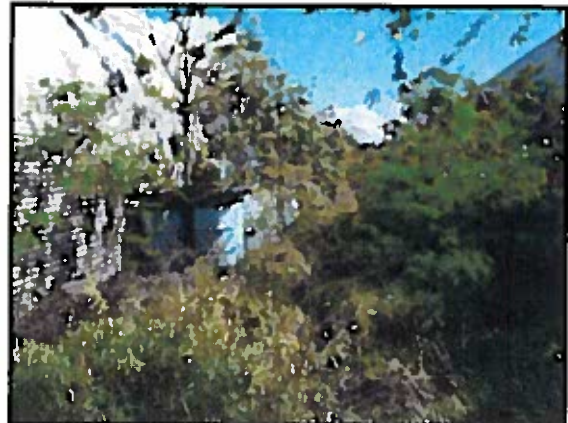
15 November 2007

Drums labeled as "MWR" located adjacent to Building 1152

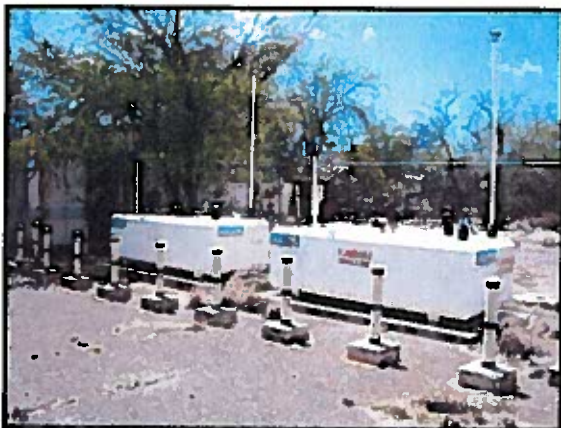
21 June 2007

Two Convault tanks located near Building 1150, one labeled gasoline, one labeled diesel

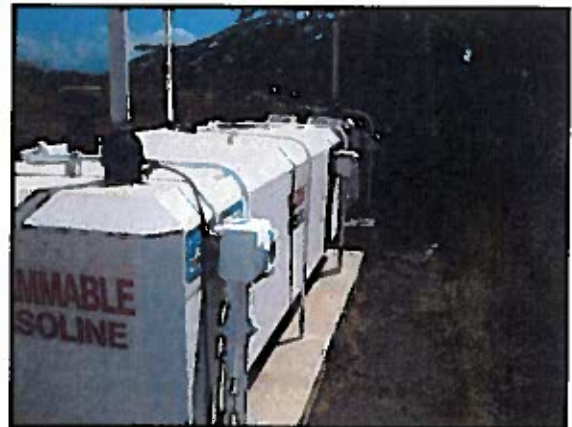
15 April 2008

AST B1150-500-01 and 02 appeared to be in good condition during the 2007 VSI

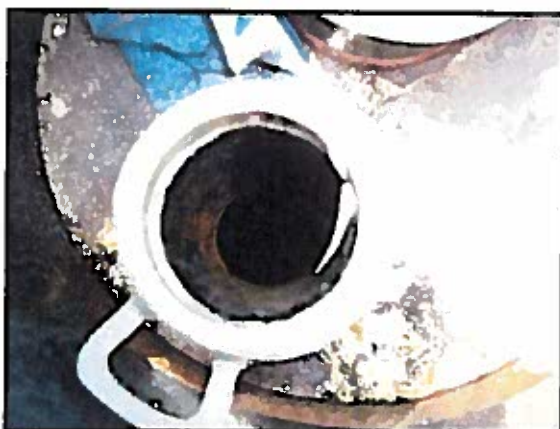
15 April 2008

Fill port for existing AST. ASTs B1150-500-01 and 02 appear to contain residual fuel / sludge

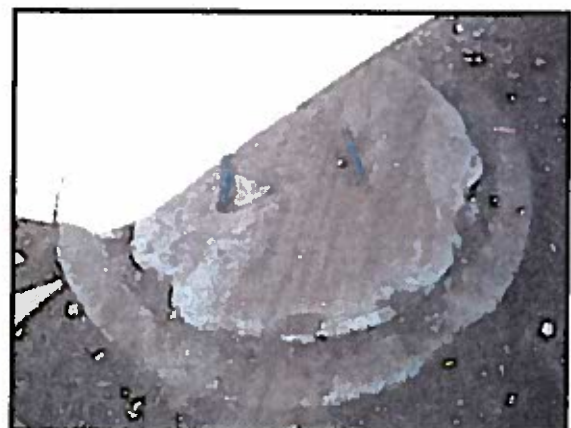
15 November 2007

Unknown concrete structure in access to MWR warehouses (similar structures elsewhere).

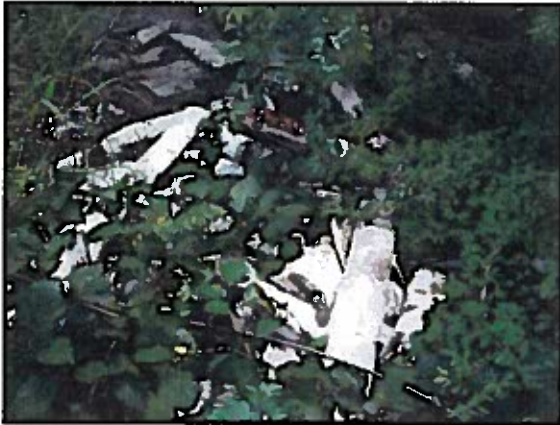
15 April 2008

PACM pipe insulation from Building 929 dumped outside the north entrance of the building.

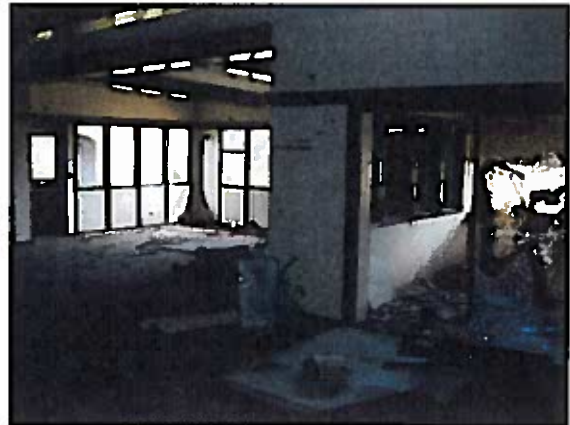
15 April 2008

Heavily vandalized interior of Building 929

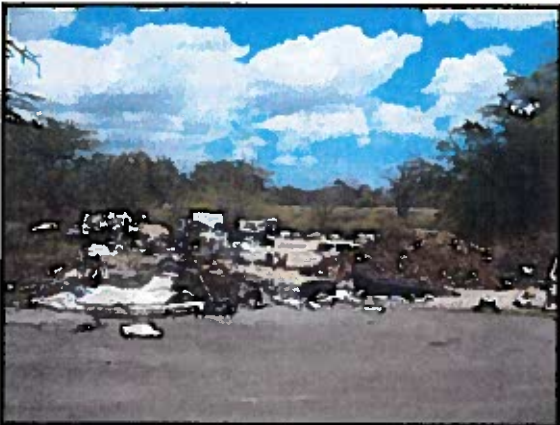
15 April 2008

Mixed household trash abandoned along Corregidor Road.

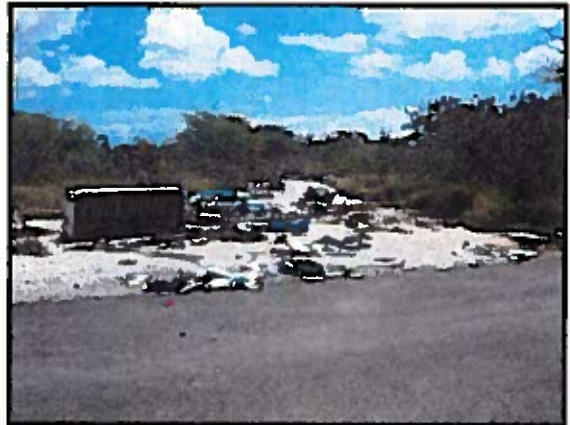
15 April 2008

Mixed household trash abandoned along Vinson Road

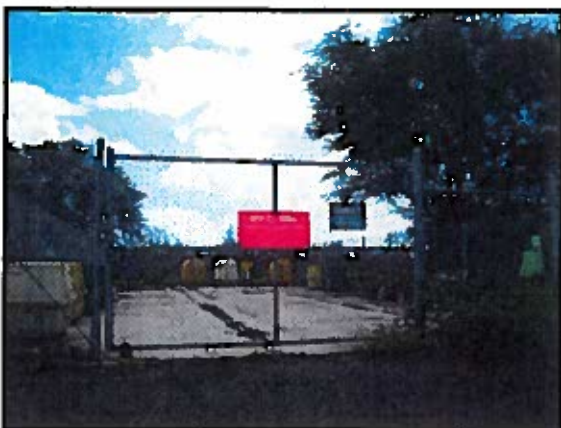
15 April 2008

NAVFAC Hawaii Hazardous Waste Accumulation Site near Corregidor Road.

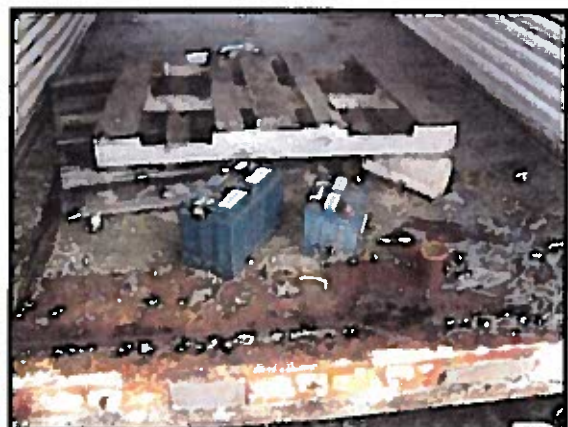
15 November 2007

Lead-acid batteries in a temporary storage container near Building 1150 (batteries removed January 2008).
